# Project Level Effectiveness Monitoring in the Estuary and Response in Fish Communities

# Effectiveness Monitoring

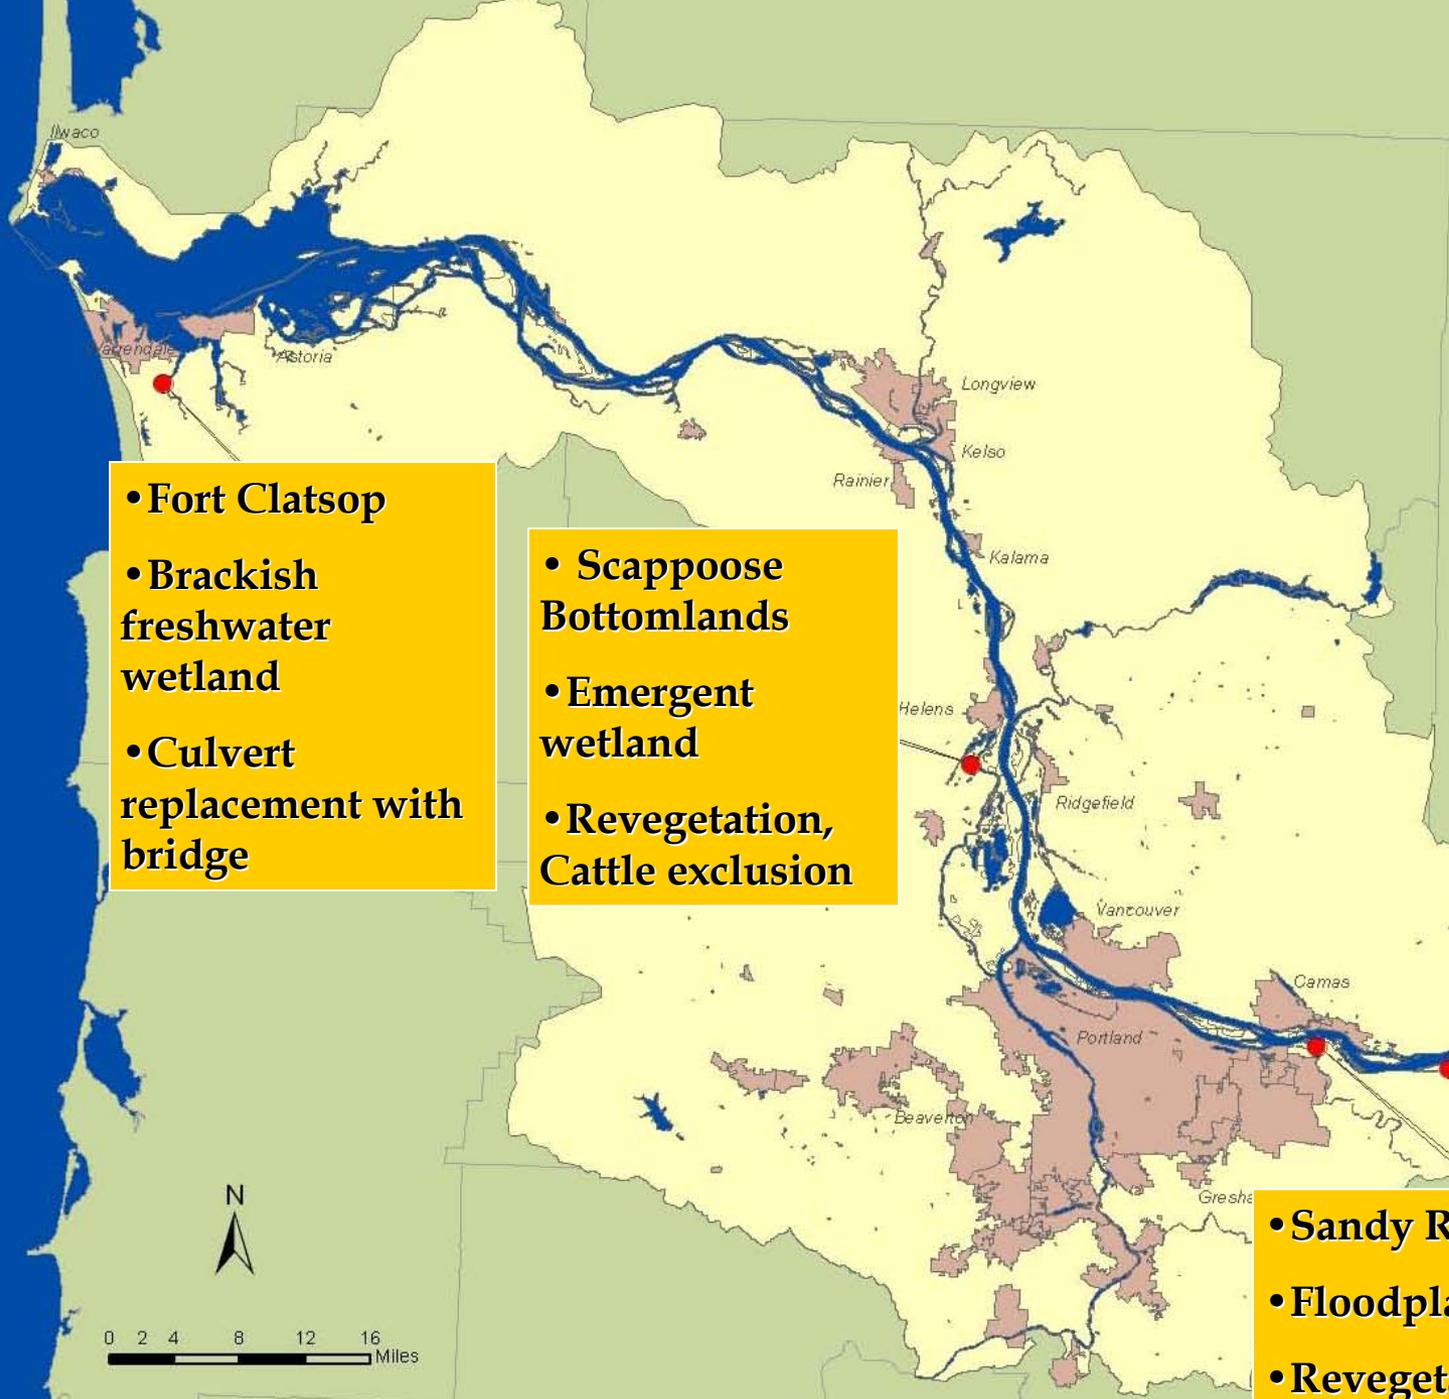
**Estuary Partnership Potential Effectiveness Monitoring Sites**

- Effectiveness Monitoring Site
- City Limits
- Study Area

- Fort Clatsop
- Brackish freshwater wetland
- Culvert replacement with bridge

- Scappoose Bottomlands
- Emergent wetland
- Revegetation, Cattle exclusion

- Mirror Lake
- Bottomland riparian forest
- LWD, Culvert enhancement, Revegetation

- Sandy River Delta
- Floodplain forest
- Revegetation

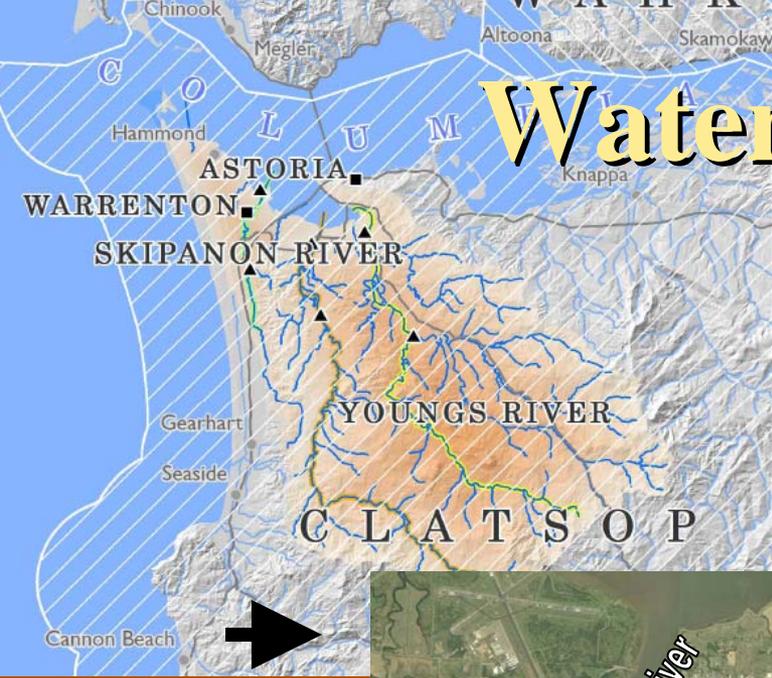
A satellite image of the Lewis & Clark River watershed. The river is labeled 'Lewis & Clark River'. Several locations are marked with arrows and text: 'Otter Point Dike Breach', 'South Slough Bridge Install', 'Seaside Dike Breach II', and 'Seaside Dike Breach I'. A large black arrow points from this image towards the zoomed-in satellite image on the right.

Otter Point  
Dike Breach

South Slough  
Bridge Install

Seaside Dike  
Breach II

Seaside Dike  
Breach I

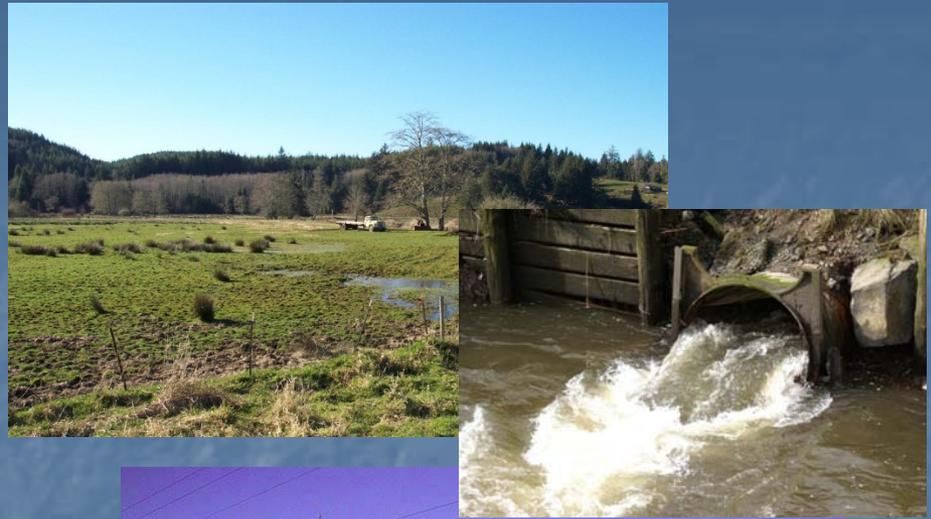
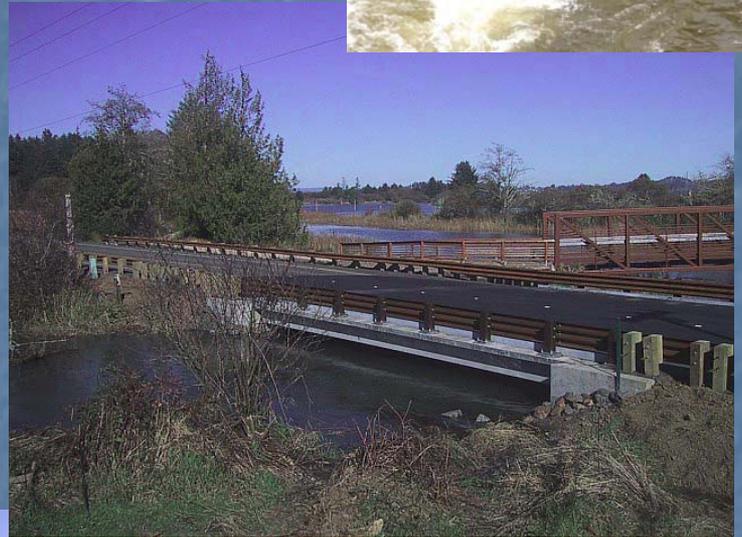
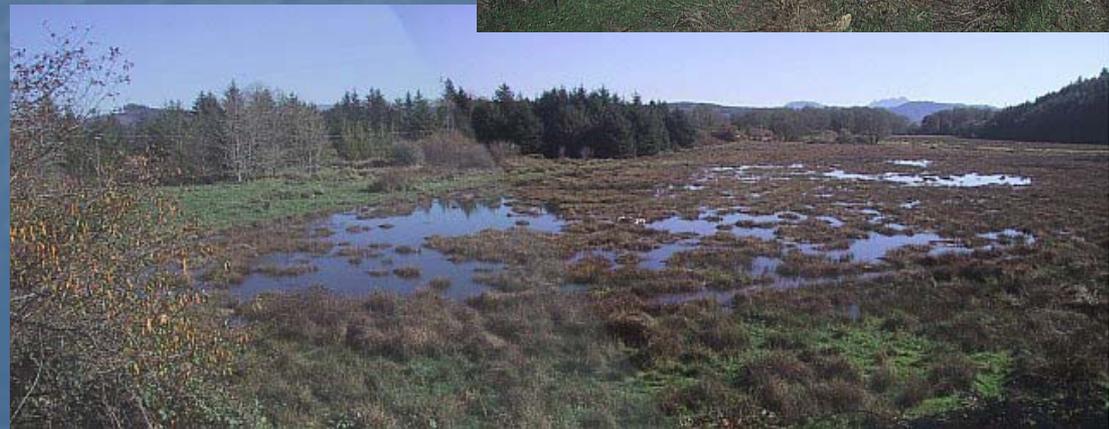
# Fort Clatsop's South Slough

- Restore tidal processes
- Reconnect 50 acres of historic off-channel rearing habitat
- Minimize risk to County Rd.

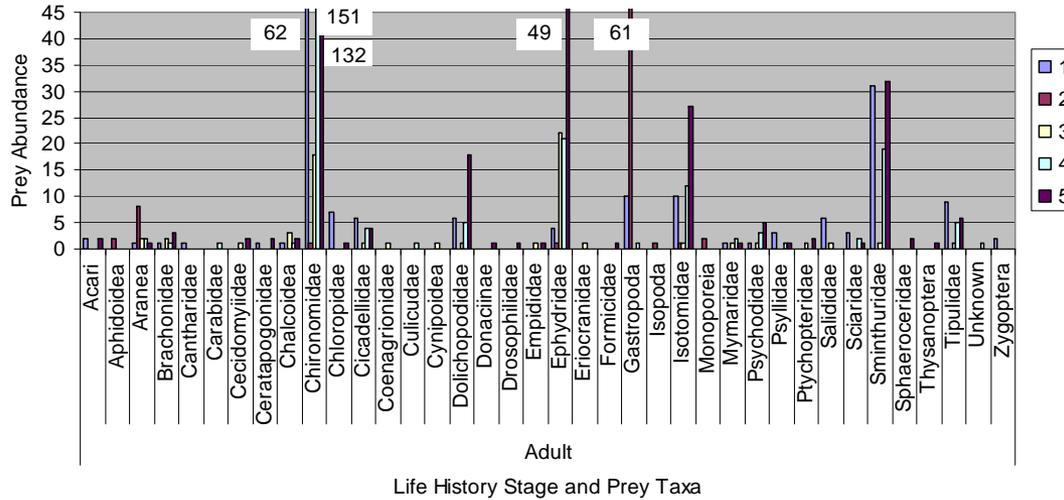
Adult Insect Prey Availability  
Ft. Clatsop South Slough  
Traps 1 through 5 (see legend)  
04 August, 2008

- Juvenile salmon occupy restoration sites in accordance with their life histories; similar abundances in restored marshes compared to mainstem tributaries.
- Juvenile salmon are utilizing the dominant prey types available in the site.
- Recruitment & migration corridor factors, as well as site maturity, may control variability in fish populations.

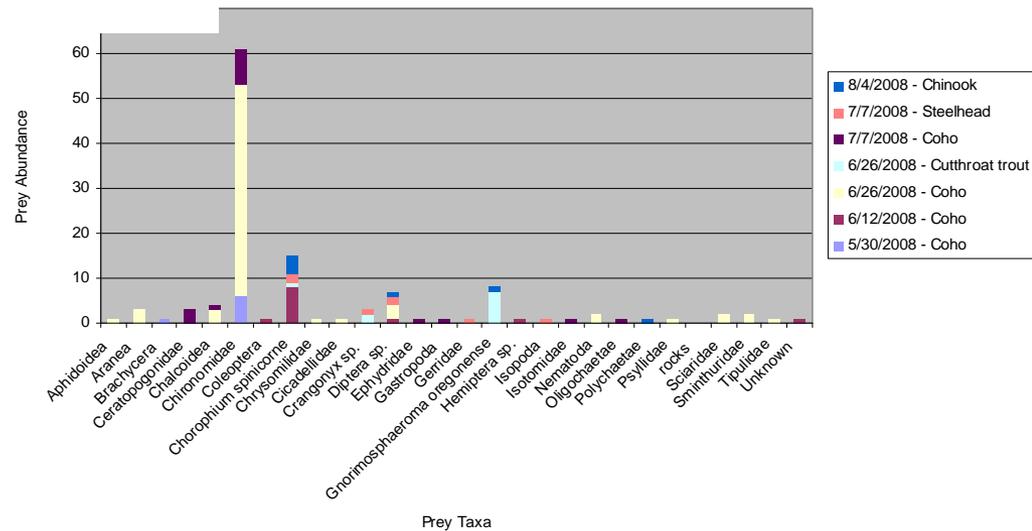
Salmonid Diet Composition  
South Slough, 2008

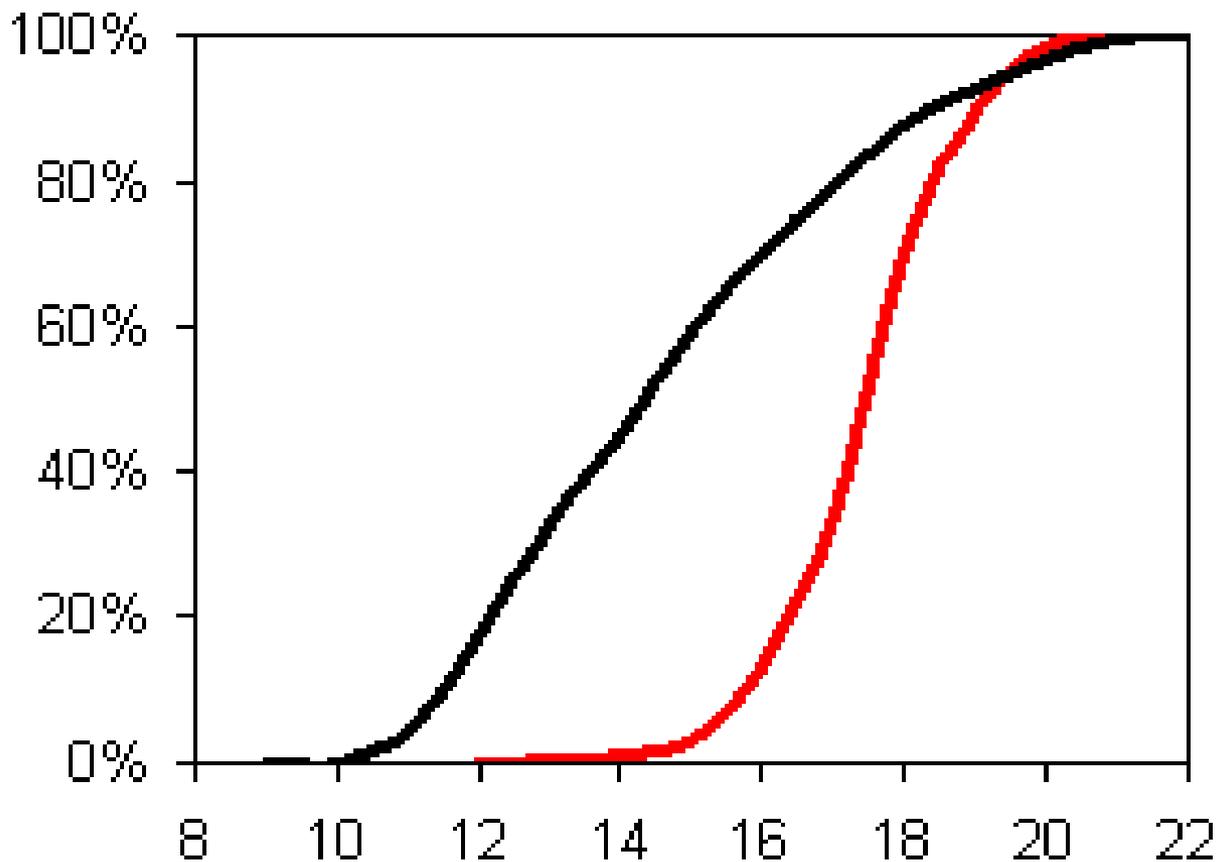
# Water Temp: South Slough

June

— Pre restoration, 2007  
— Post restoration, 2008

Result:  
Water  
temperatures  
were lower  
post  
restoration
